ENVIRONMENTAL CHECKLIST GUIDANCE

Cherry Hills Estate, White Salmon (WA)

AMENDED: NOVEMBER 28, 2023, BY HRK ENGINEERING & FIELD SERVICES

Cherry Hill Estates Subdivision

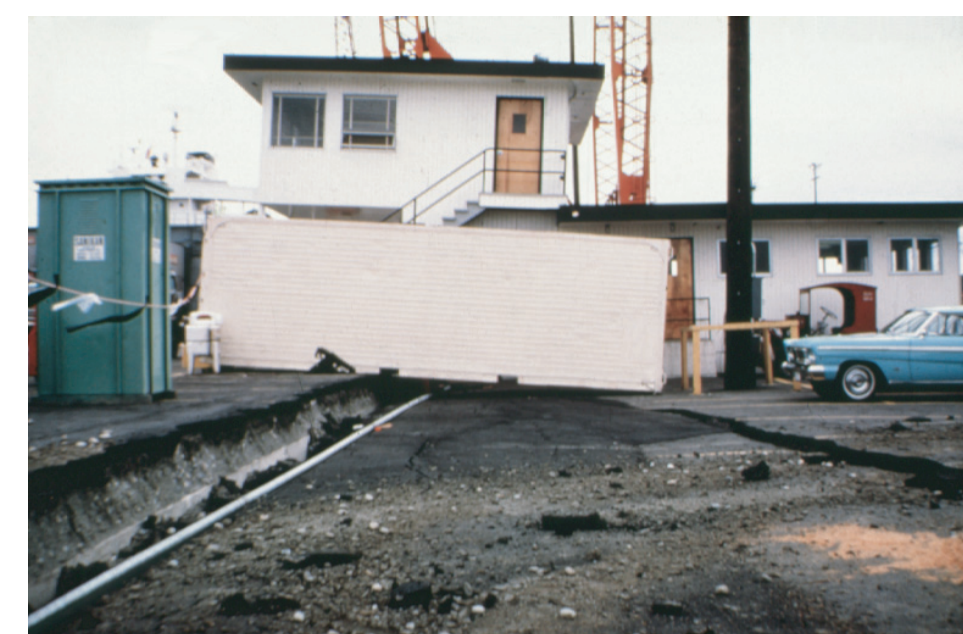
Liquefaction during the 1965 SoTac earthquake caused both lateral and vertical movement of the ground in the Port of Seattle. Cargo cranes such as the one in the background are vulnerable to liquefaction-induced ground displacement. Lateral spreading such as this can cause severe damage to both above-ground structures and underground utilities. Photo courtesy of the Karl V. Steinbrugge Collection, Earthquake Engineering Research Center [http://misc.berkeley.edu/visual_resources/steinbrugge_collection.html].

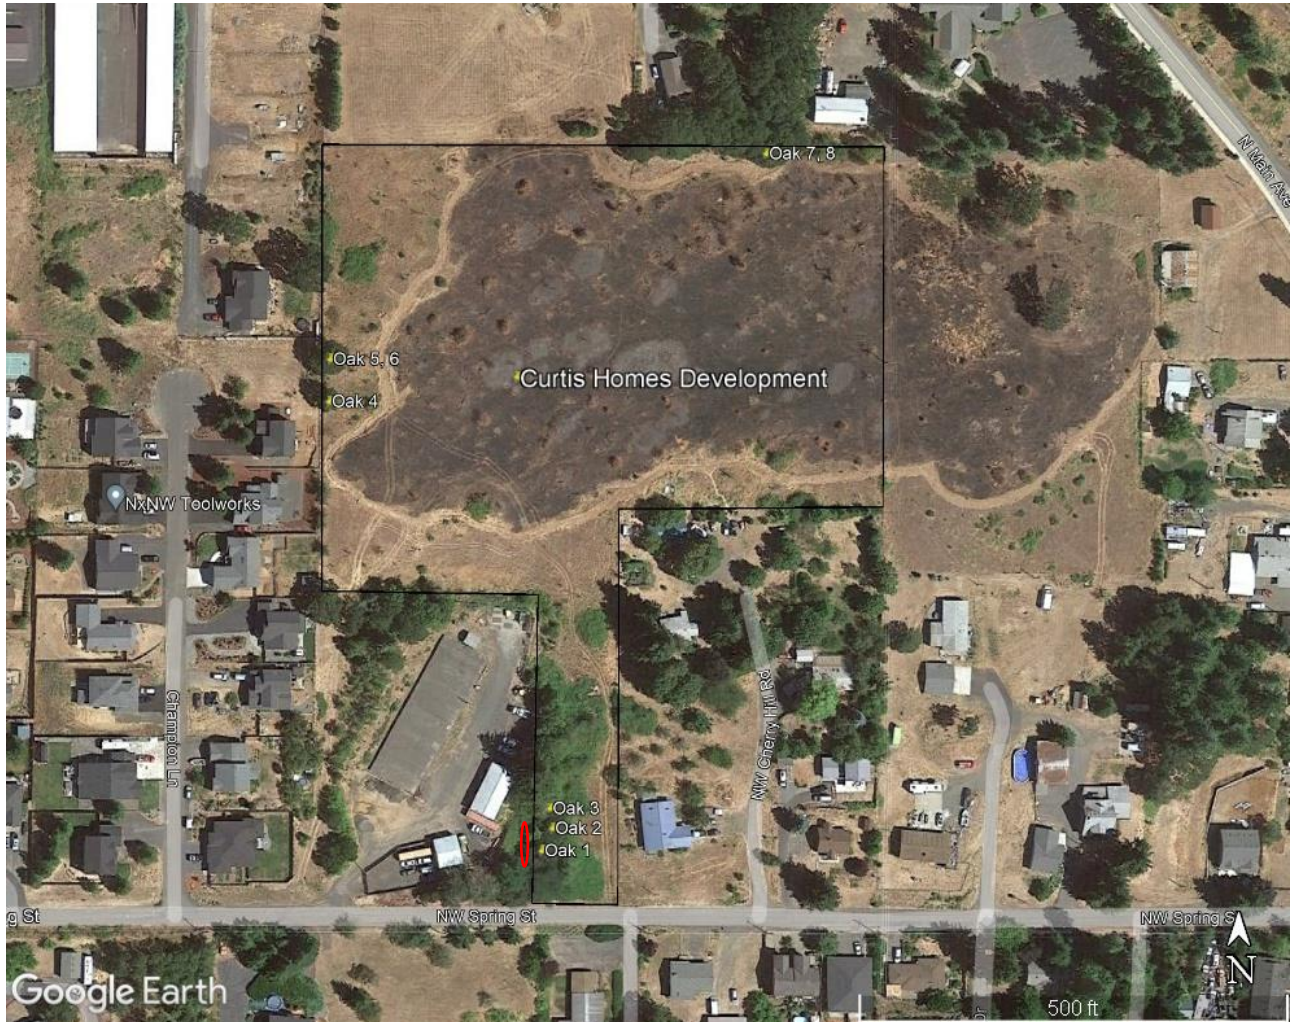
Figure I. Candidate Heritage Trees. Eight Oregon White Oaks qualify as Heritage Trees based on species and diameter. Condition was fair or good, and all were determined to be at a hazard level of “low risk”, based on improvements such as homes, common areas, sidewalks, and roads built within 1.5 tree heights of the trees. Diameter ranged from 14 to 25 in., and heights from 25 – 40 ft. Trees are near property boundaries: Oaks #1, #2, and #3 are along the west boundary in the southern, narrow neck of the property; oaks #4, #5, and #6 are along the west boundary, and oaks #7 and #8 are along the north boundary. Oak #2 was the farthest from a boundary, about 20 ft. east of the west boundary along the narrow neck of the property at bottom. The property approximated by the black lines is Tax Lot 4, 7.93 ac., # 0310247500400. Aerial photo date is July 24th, 2021.

Oak #2 would be closest to the access road of the three trees in the narrow area; its HTPA would be 18.3 ft. (22 in. dbh * 10) + a BSBL of (15 ft.)*2 ft., or a circle 48 ft. in diameter. This would put the edge of the protection area about 44 ft. from the west property line and 6 ft. west of the center of the 101 ft. wide area (the tree is about 20 ft. from the west boundary).

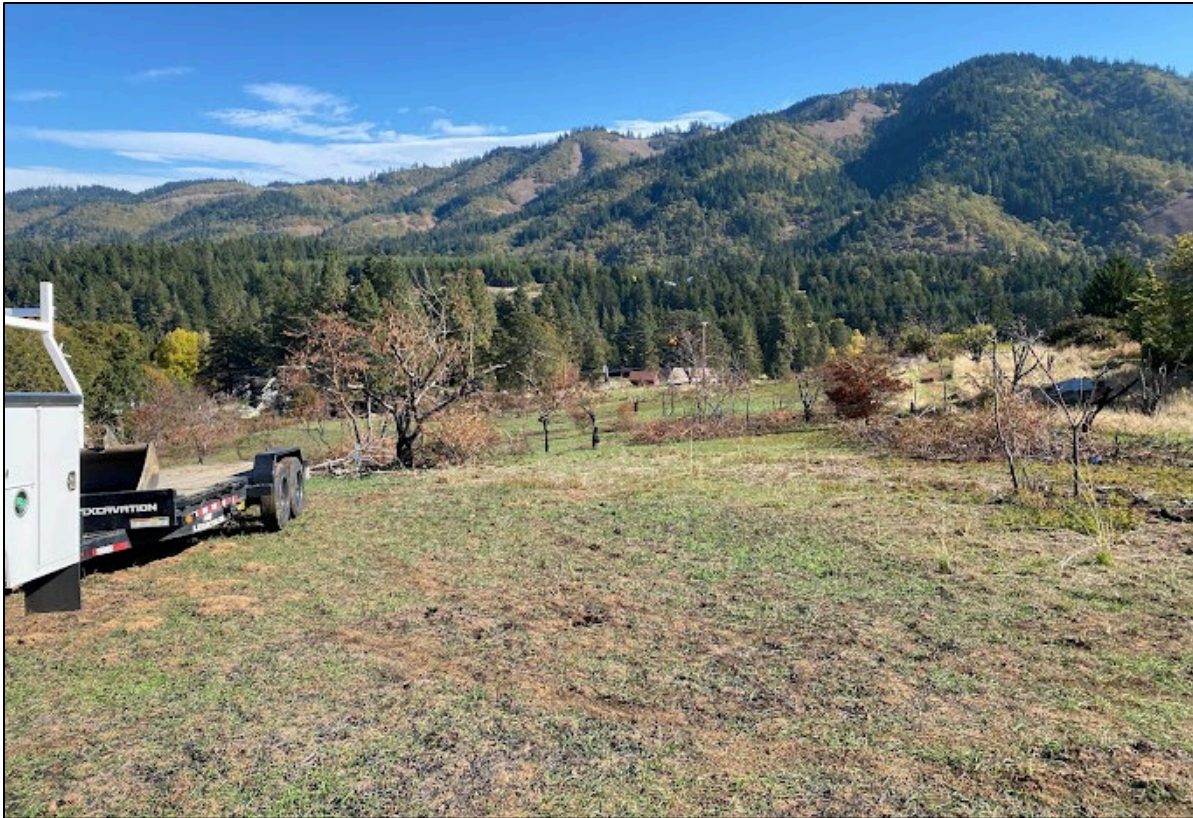
Photo 1: Current site conditions (taken from TP-3, facing northeast).

While on site, we did not observe signs of previous or current soil movement, such as leaning tree trunks, clearly identifiable landslide head scarps, or surface cracking in the soils. See Photos 1 through 4 below for current site conditions.

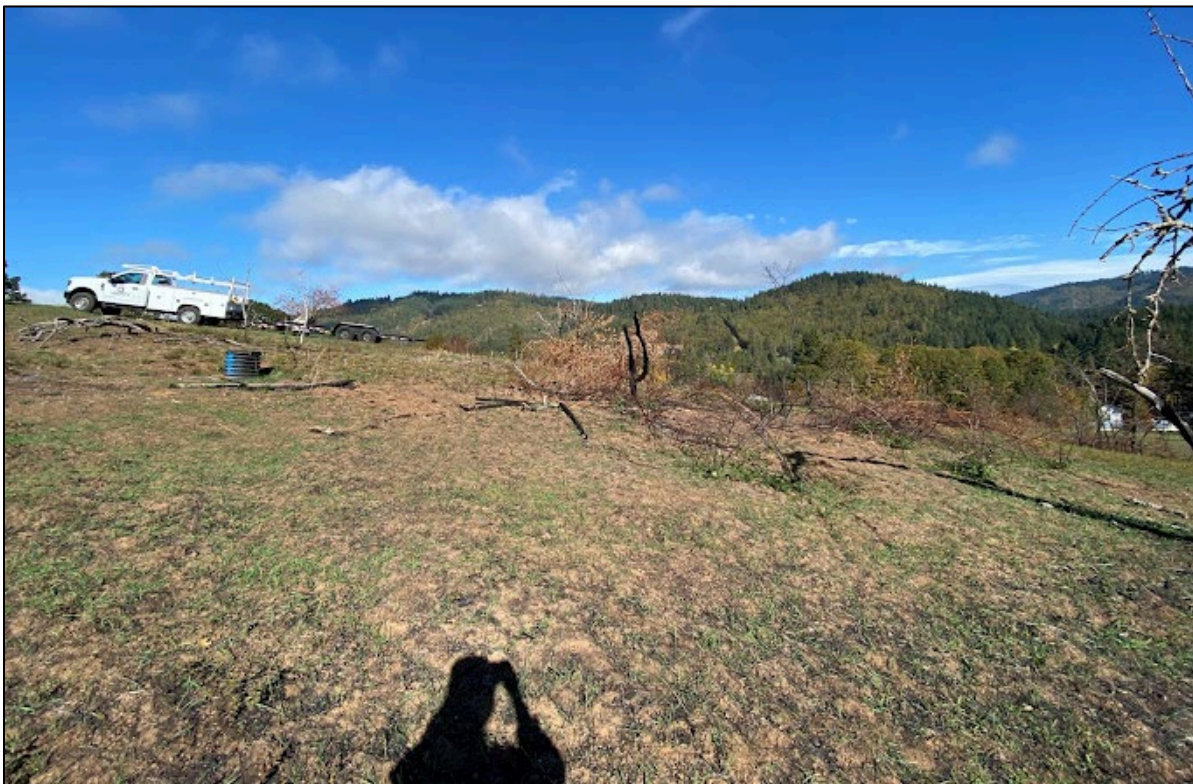
Photo 2: Current site conditions (taken from TP-4, facing north).

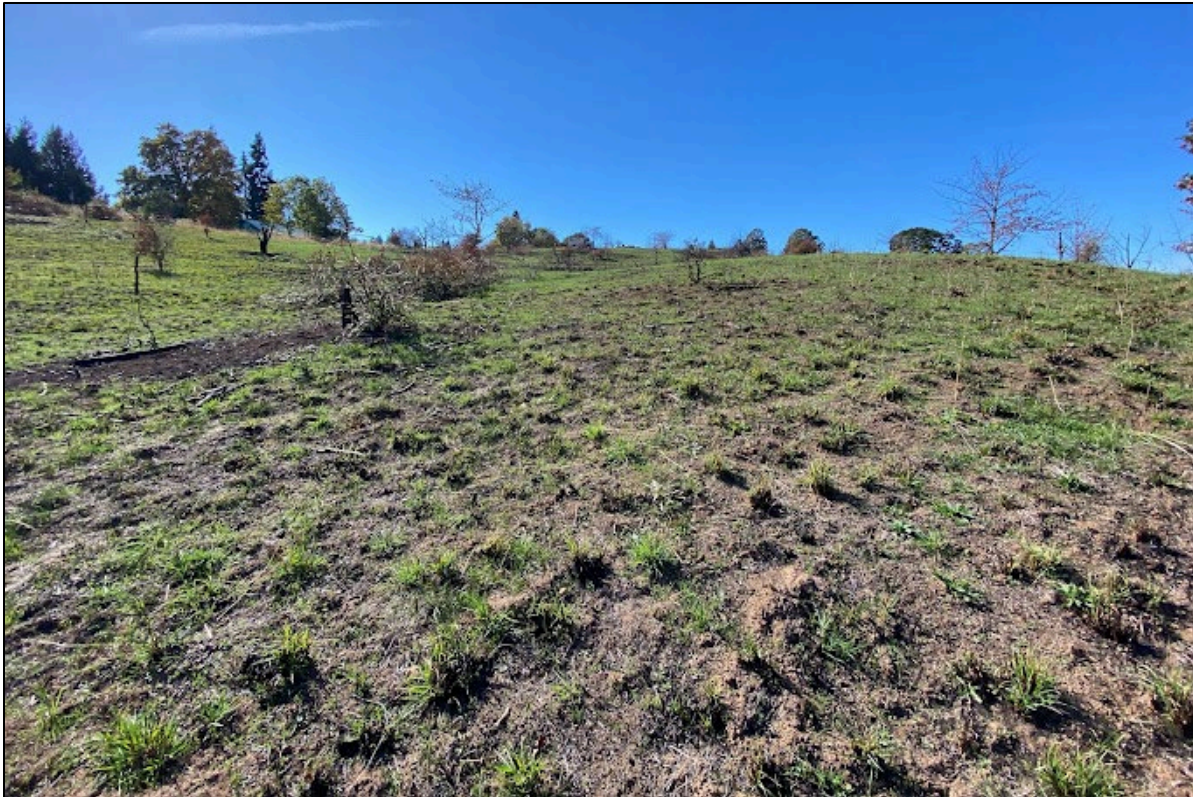
Photo 3: Current site conditions (taken from TP-8, facing southwest).

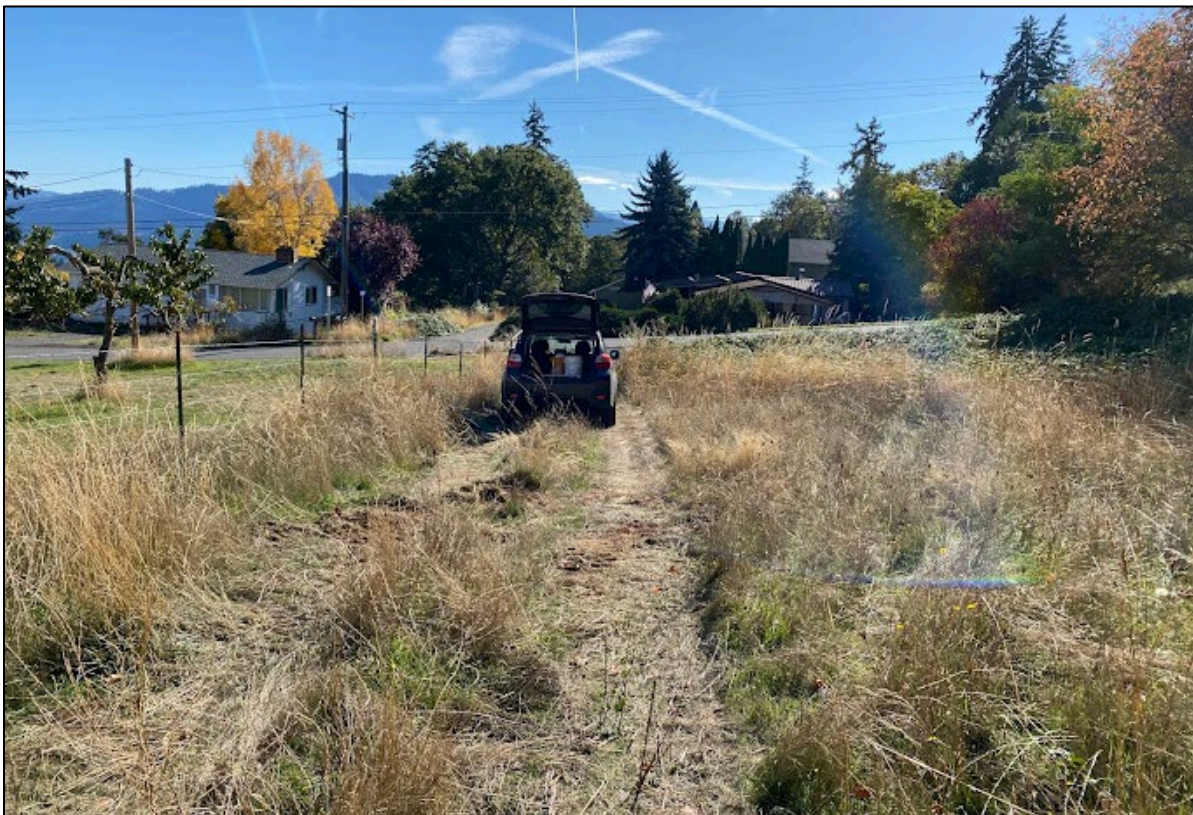
Photo 4: Current site conditions (taken from TP-11, facing Northwest Spring Street to the south).
