City of White Salmon
 Recommendation to Planning
 Commission

Cherry Hill Estates Preliminary
 Plat

WS-SUB-2024.001 and WS-SEPA-2024.001
 Applicants: Alex Pedroza of HRK Engineering &
 Field Services, representing Cherry Hill NW, LLC
 and Cameron Curtis of Legacy Development
 Group

STAFF RECOMMENDATION
 Amended December 5, 2024

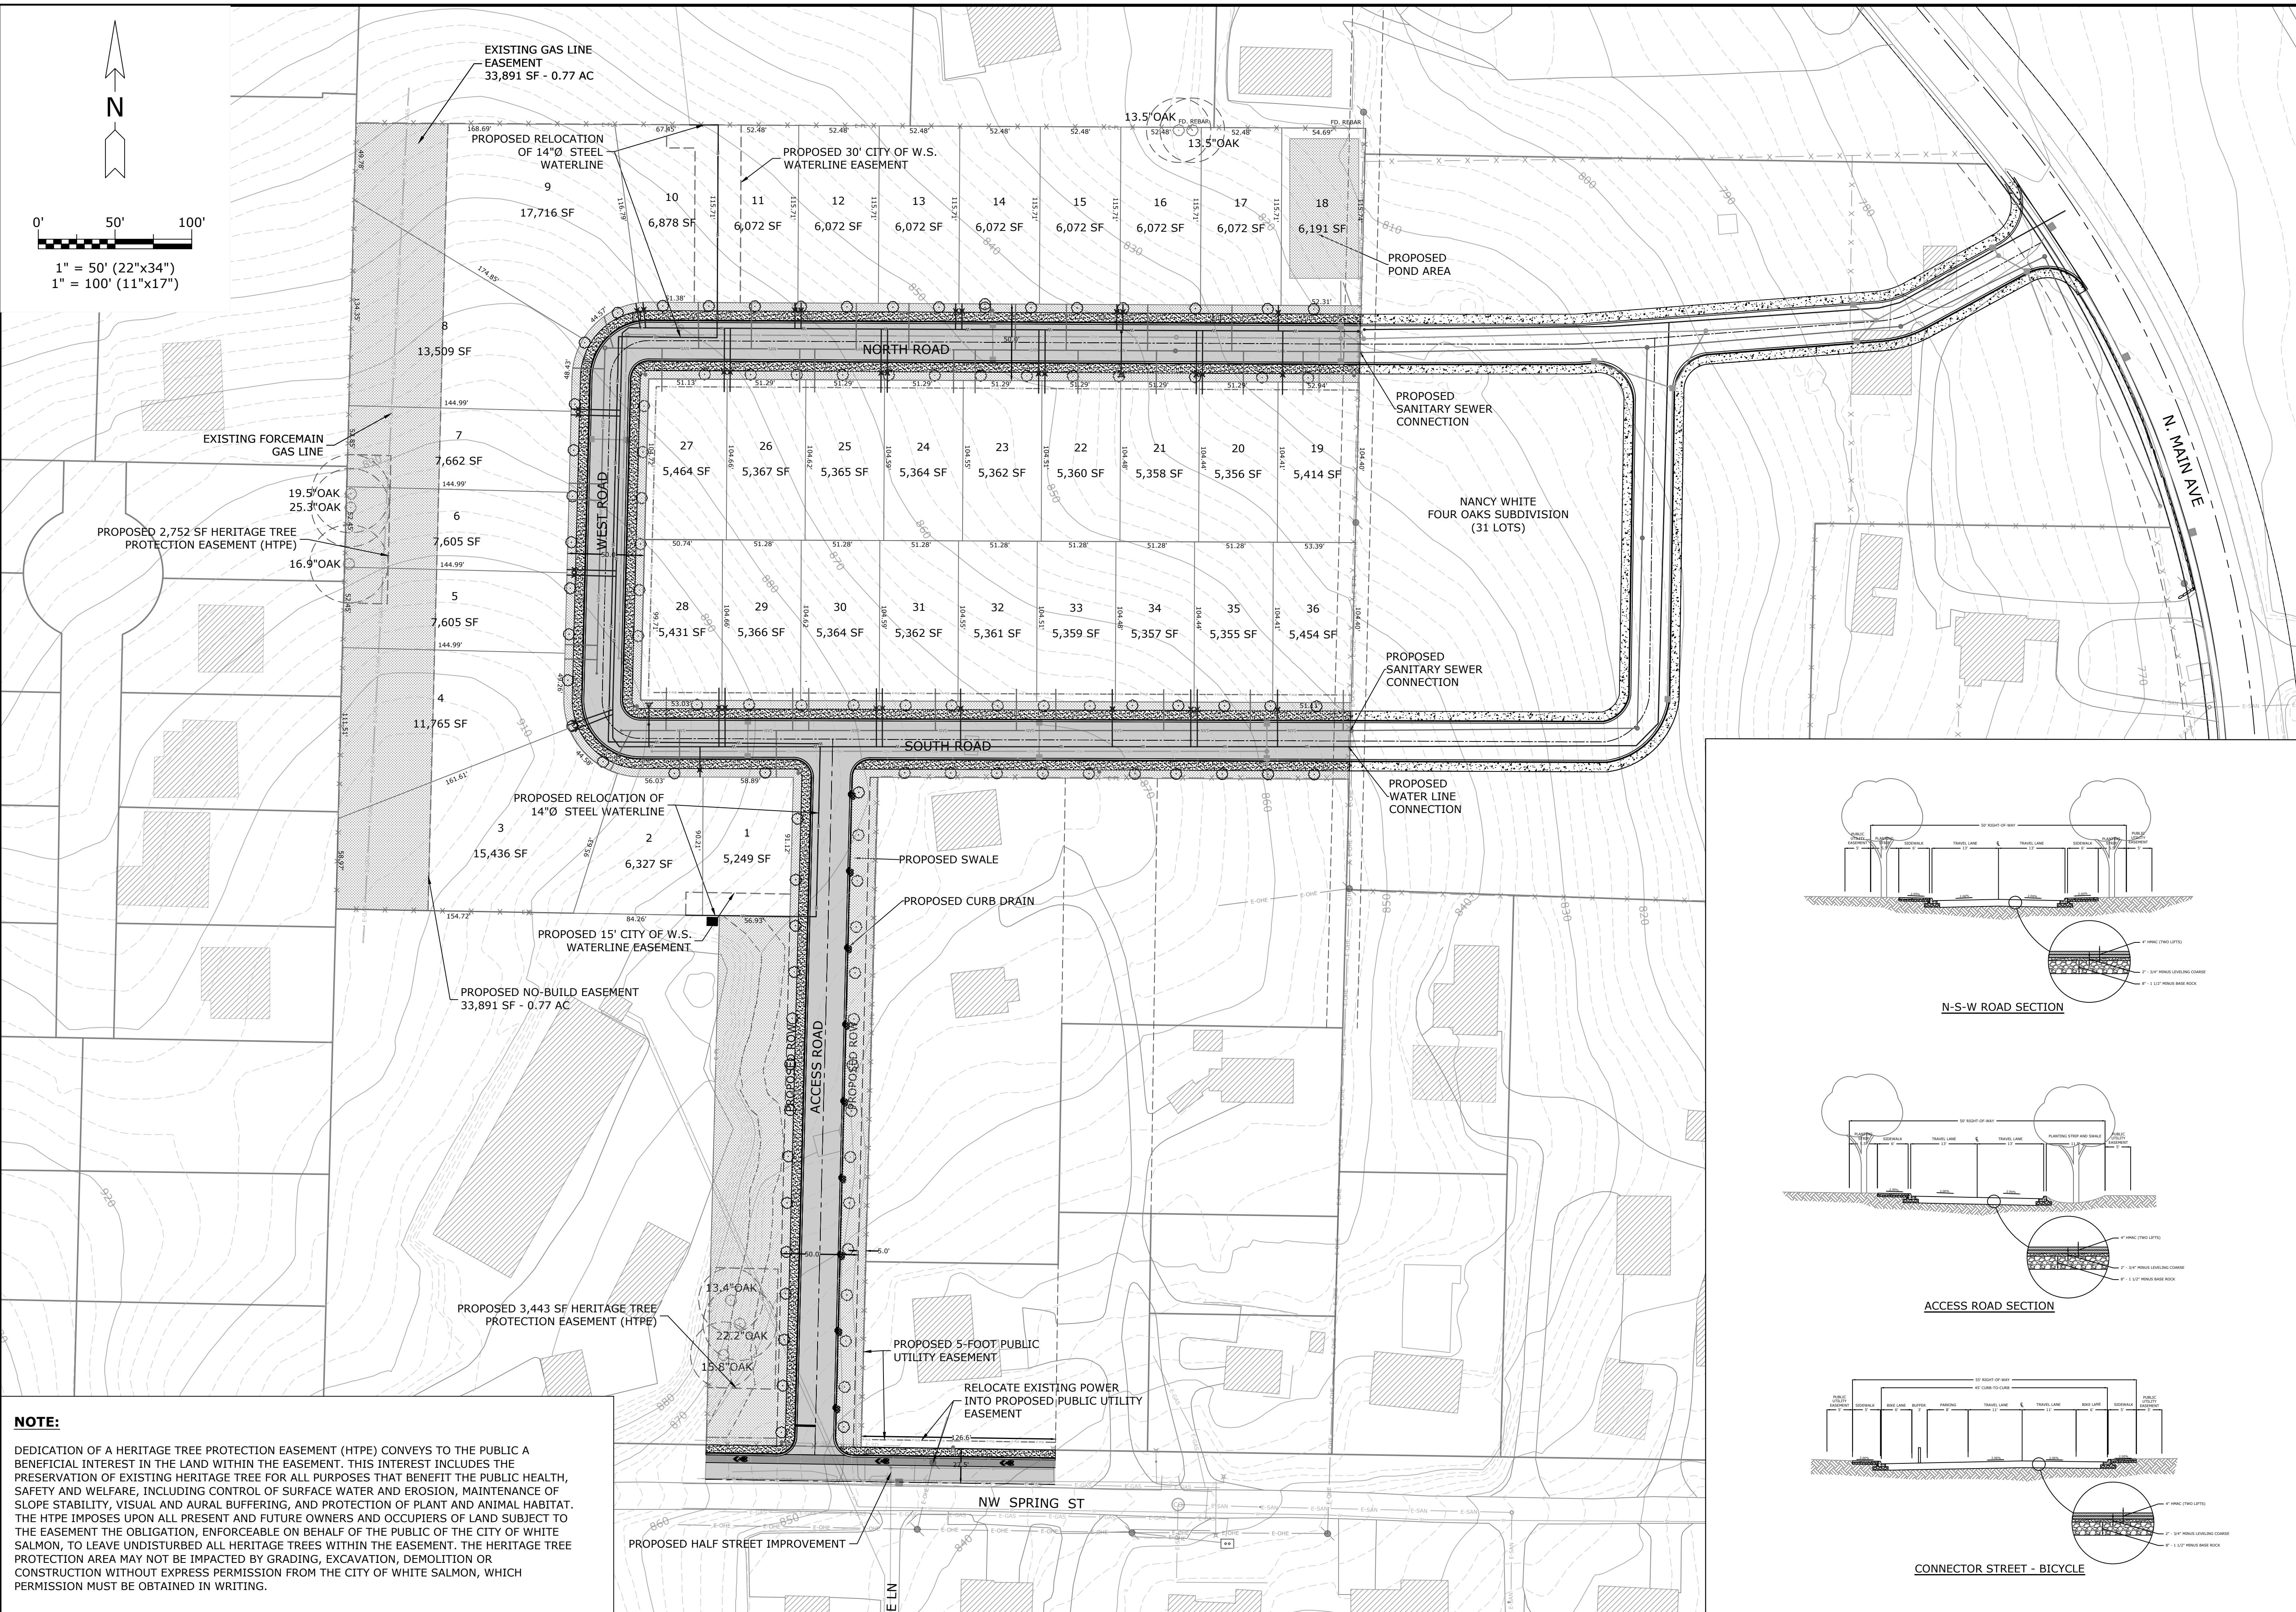
SHEET NO. **2** OF 4

NOTE:
 DEDICATION OF A HERITAGE TREE PROTECTION EASEMENT (HTPE) CONVEYS TO THE PUBLIC A BENEFICIAL INTEREST IN THE LAND WITHIN THE EASEMENT. THIS INTEREST INCLUDES THE PRESERVATION OF EXISTING HERITAGE TREE FOR ALL PURPOSES THAT BENEFIT THE PUBLIC HEALTH, SAFETY AND WELFARE, INCLUDING CONTROL OF SURFACE WATER AND EROSION, MAINTENANCE OF SLOPE STABILITY, VISUAL AND AURAL BUFFERING, AND PROTECTION OF PLANT AND ANIMAL HABITAT. THE HTPE IMPOSES UPON ALL PRESENT AND FUTURE OWNERS AND OCCUPIERS OF LAND SUBJECT TO THE EASEMENT THE OBLIGATION, ENFORCEABLE ON BEHALF OF THE PUBLIC OF THE CITY OF WHITE SALMON, TO LEAVE UNDISTURBED ALL HERITAGE TREES WITHIN THE EASEMENT. THE HERITAGE TREE PROTECTION AREA MAY NOT BE IMPACTED BY GRADING, EXCAVATION, DEMOLITION OR CONSTRUCTION WITHOUT EXPRESS PERMISSION FROM THE CITY OF WHITE SALMON, WHICH PERMISSION MUST BE OBTAINED IN WRITING.

CONDITION OF APPROVAL: Prior to final plat, Applicant shall retain heritage trees on the final plat map for and show their protective easements (HTPEs) on the face of plat for those encumbering the access road area as it approaches NW Spring St.

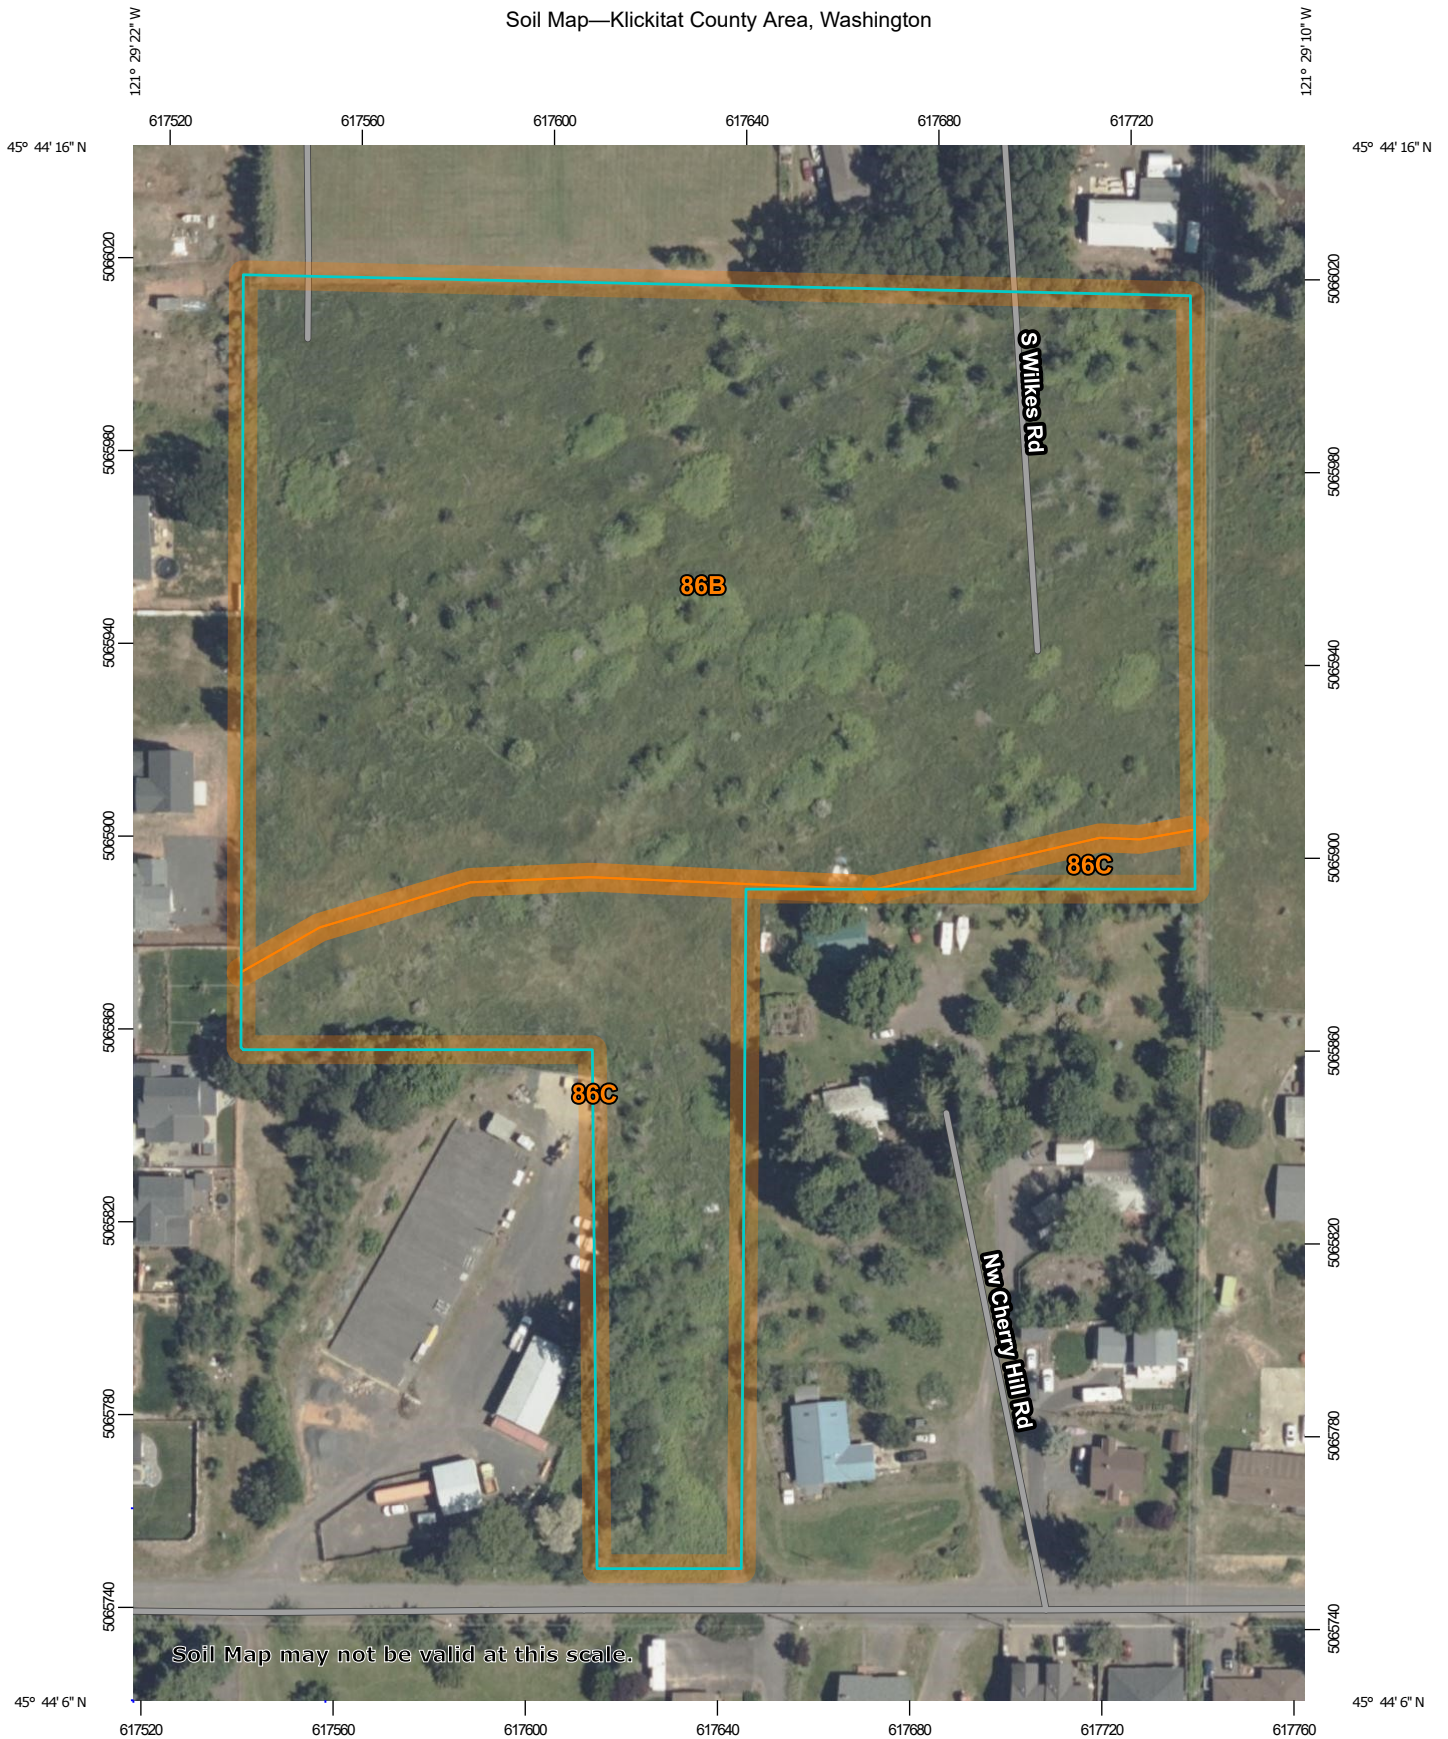
Soil Map—Klickitat County Area, Washington

Soil Map may not be valid at this scale.

Map Scale: 1:1,570 if printed on A portrait (8.5" x 11") sheet.

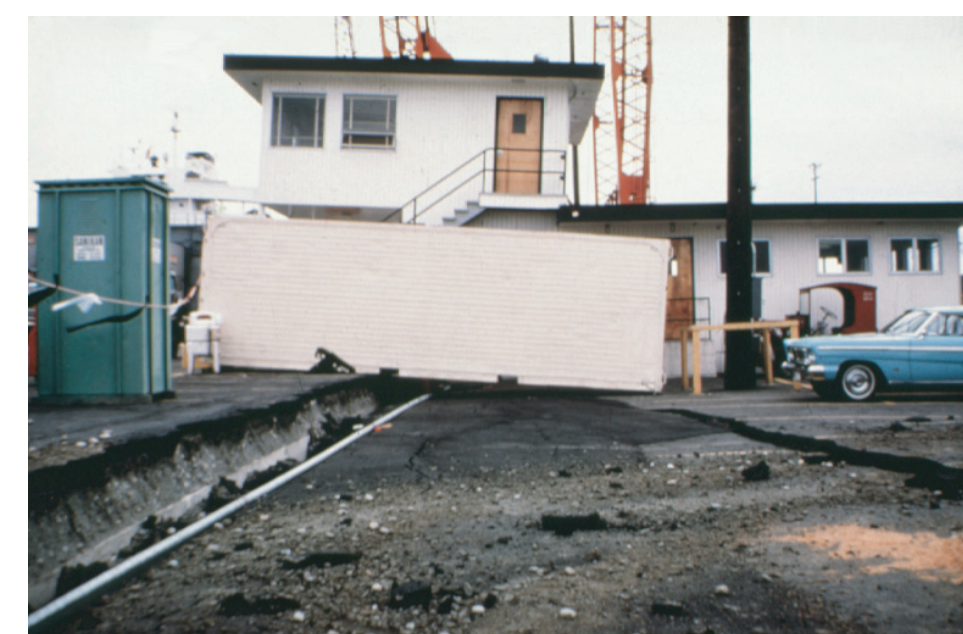
Liquefaction during the 1965 SoTac earthquake caused both lateral and vertical movement of the ground in the Port of Seattle. Cargo cranes such as the one in the background are vulnerable to liquefaction-induced ground displacement. Lateral spreading such as this can cause severe damage to both above-ground structures and underground utilities. Photo courtesy of the Karl V. Steinbrugge Collection, Earthquake Engineering Research Center [http://misc.berkeley.edu/visual_resources/steinbrugge_collection.html].

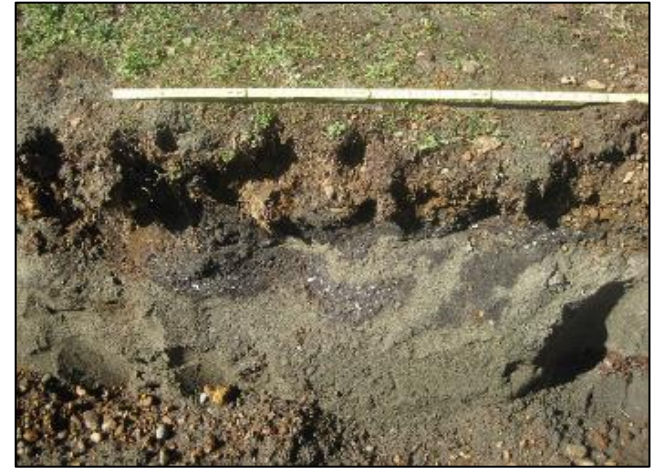
Shell Midden pocket in modern fill discovered in sewer trench.

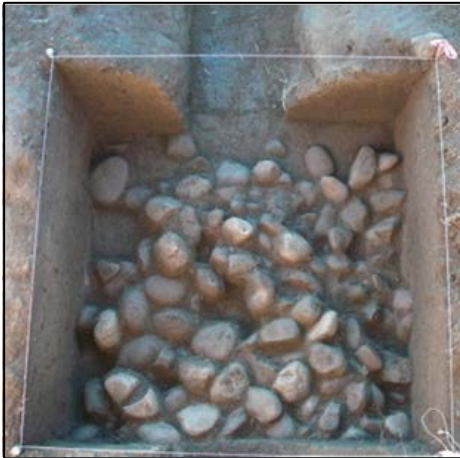
Underground oven. Courtesy of DAHP.

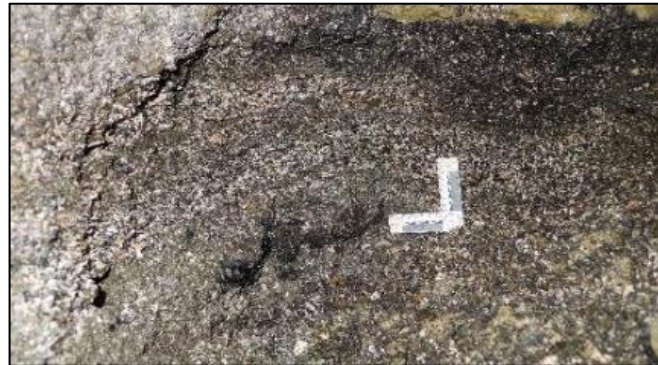
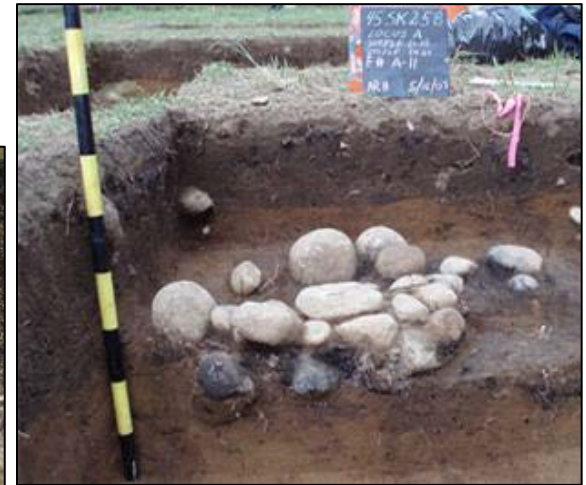
Shell midden with fire cracked rock.

Hearth excavated near Hamilton, WA.

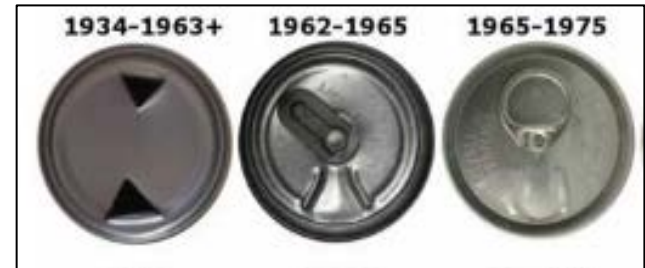
Can opening dates, courtesy of W.M. Schroeder.

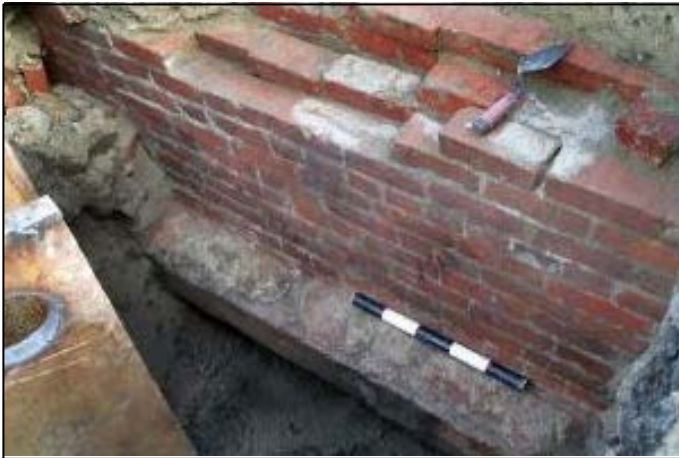
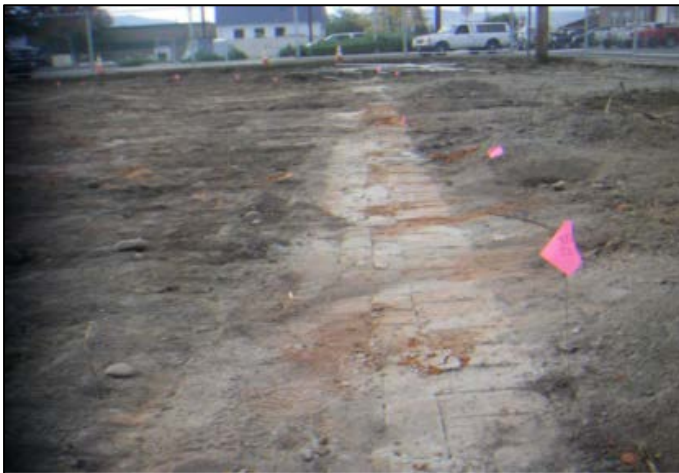
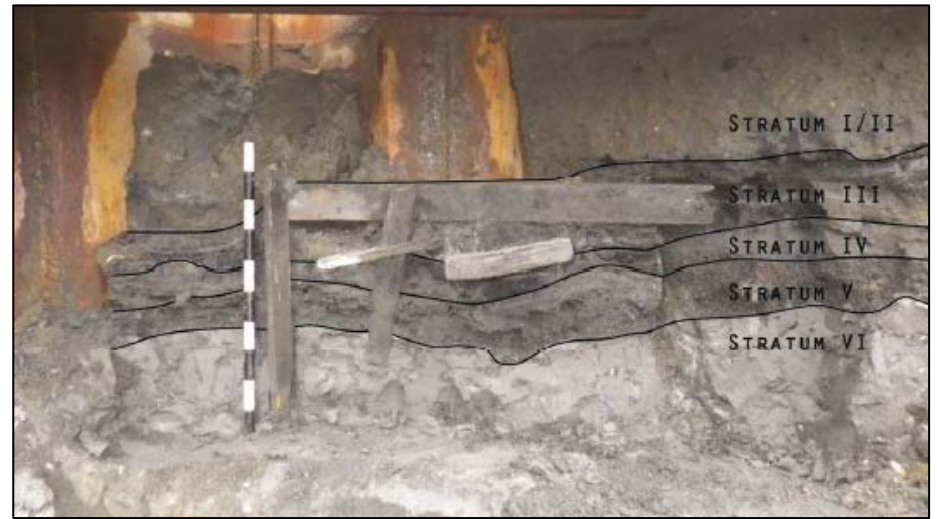
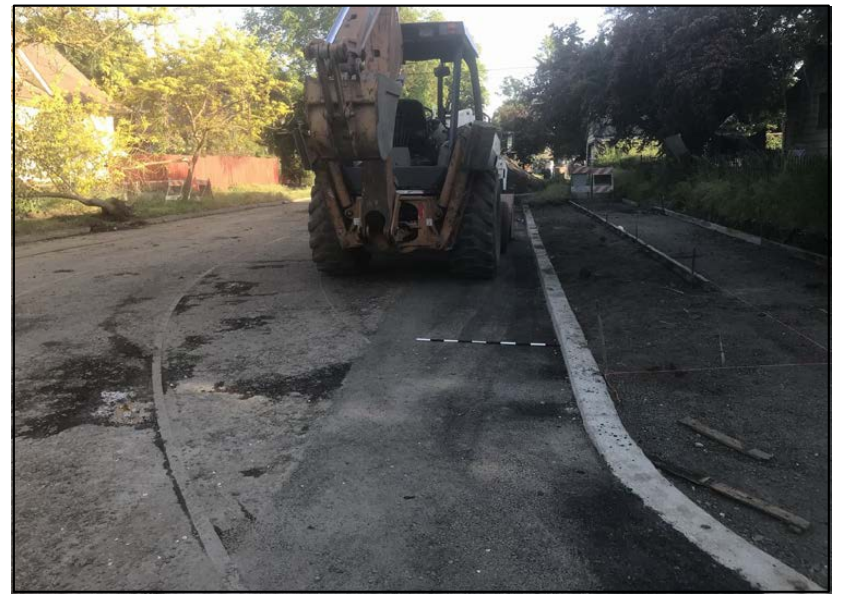
Counter Clockwise, Left to Right: *Historic structure 45KI924, in WSDOT right of way for SR99 tunnel. Remnants of Smith Cove shantytown (45-KI-1200) discovered during Ecology CSO excavation, City of Spokane historic trolley tracks uncovered during stormwater project, intact foundation of historic home that survived the Great Ellensburg Fire of July 4, 1889, uncovered beneath parking lot in Ellensburg.*

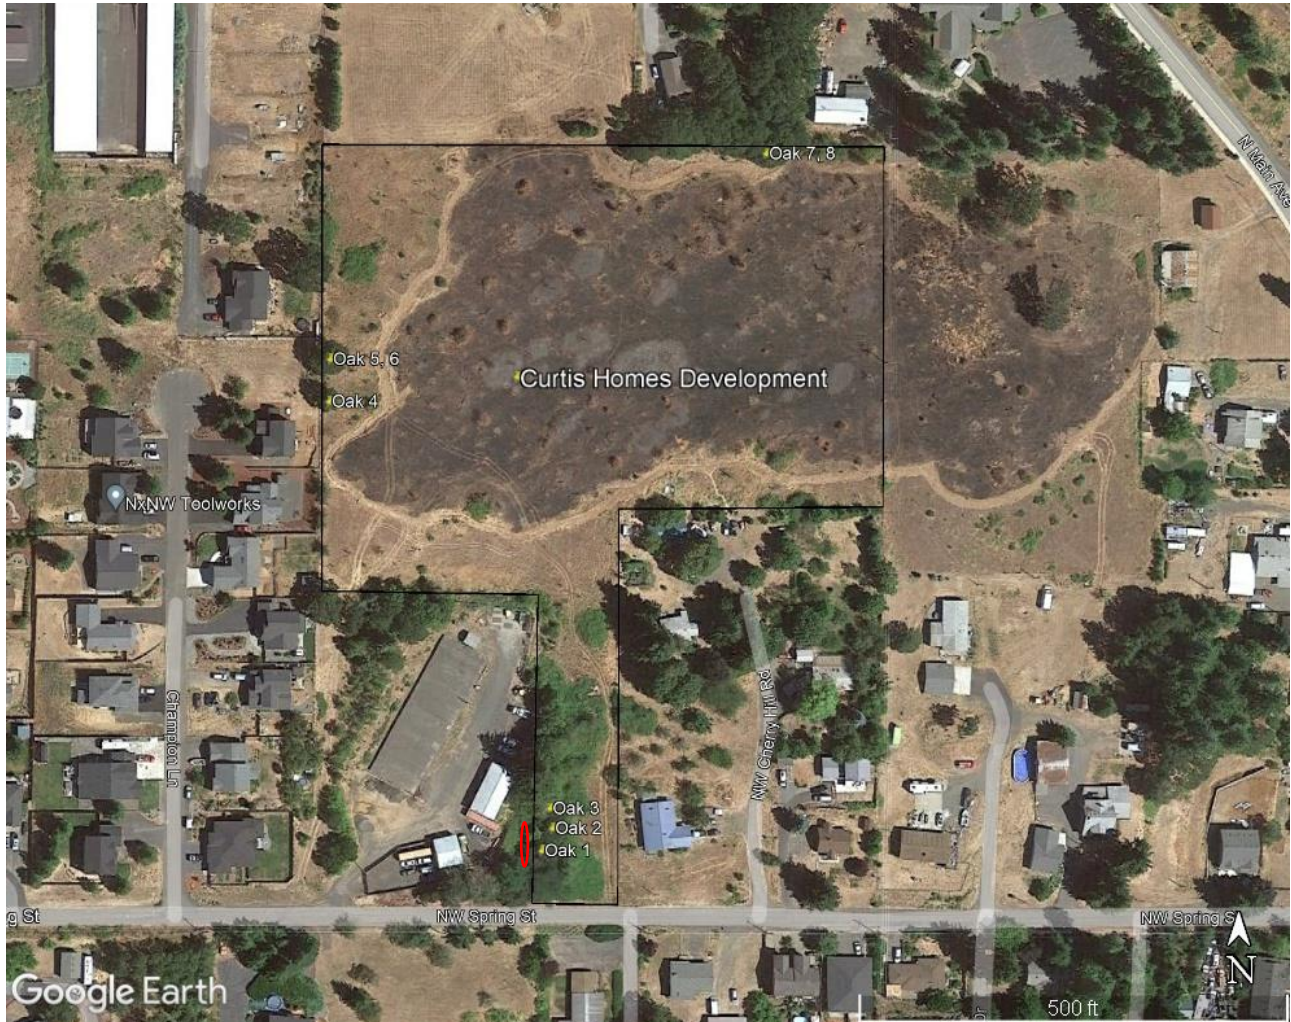
Figure I. Candidate Heritage Trees. Eight Oregon White Oaks qualify as Heritage Trees based on species and diameter. Condition was fair or good, and all were determined to be at a hazard level of “low risk”, based on improvements such as homes, common areas, sidewalks, and roads built within 1.5 tree heights of the trees. Diameter ranged from 14 to 25 in., and heights from 25 – 40 ft. Trees are near property boundaries: Oaks #1, #2, and #3 are along the west boundary in the southern, narrow neck of the property; oaks #4, #5, and #6 are along the west boundary, and oaks #7 and #8 are along the north boundary. Oak #2 was the farthest from a boundary, about 20 ft. east of the west boundary along the narrow neck of the property at bottom. The property approximated by the black lines is Tax Lot 4, 7.93 ac., # 0310247500400. Aerial photo date is July 24th, 2021.

Oak #2 would be closest to the access road of the three trees in the narrow area; its HTPA would be 18.3 ft. (22 in. dbh * 10) + a BSBL of (15 ft.)*2 ft., or a circle 48 ft. in diameter. This would put the edge of the protection area about 44 ft. from the west property line and 6 ft. west of the center of the 101 ft. wide area (the tree is about 20 ft. from the west boundary).

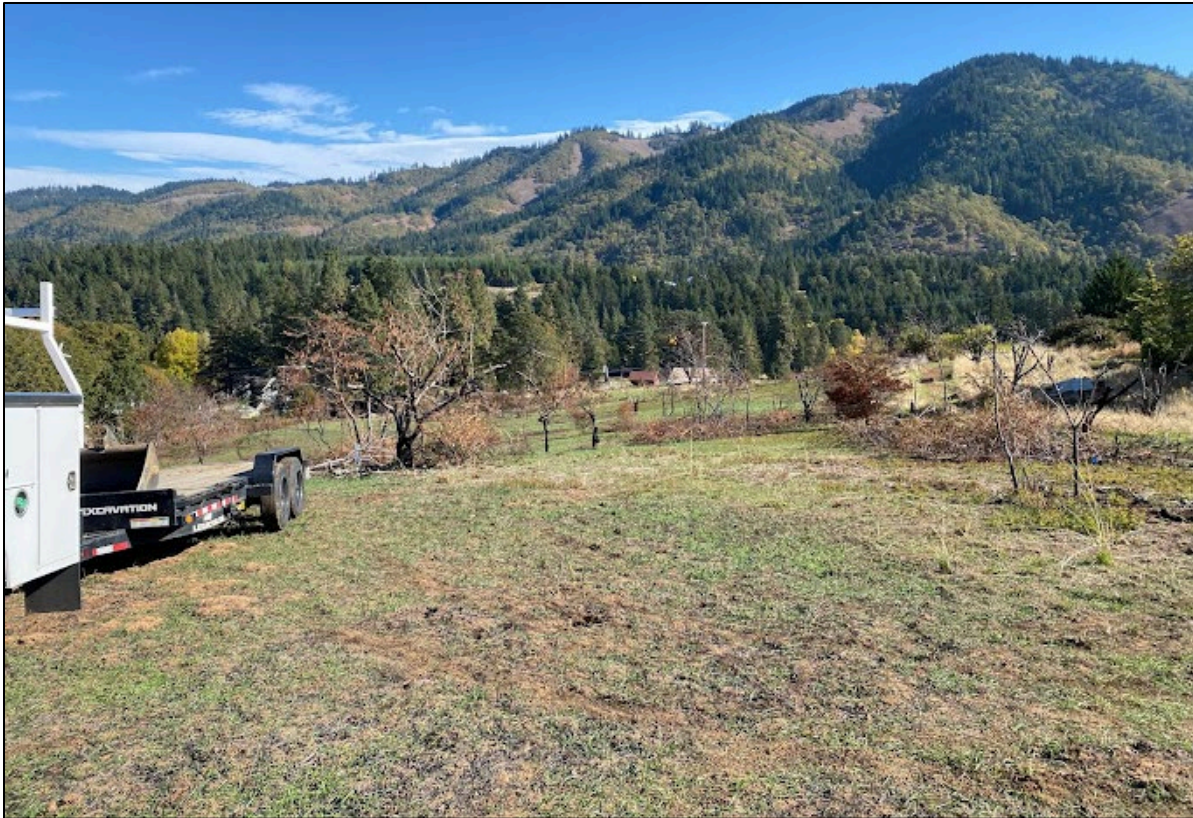
Photo 1: Current site conditions (taken from TP-3, facing northeast).

While on site, we did not observe signs of previous or current soil movement, such as leaning tree trunks, clearly identifiable landslide head scarps, or surface cracking in the soils. See Photos 1 through 4 below for current site conditions.

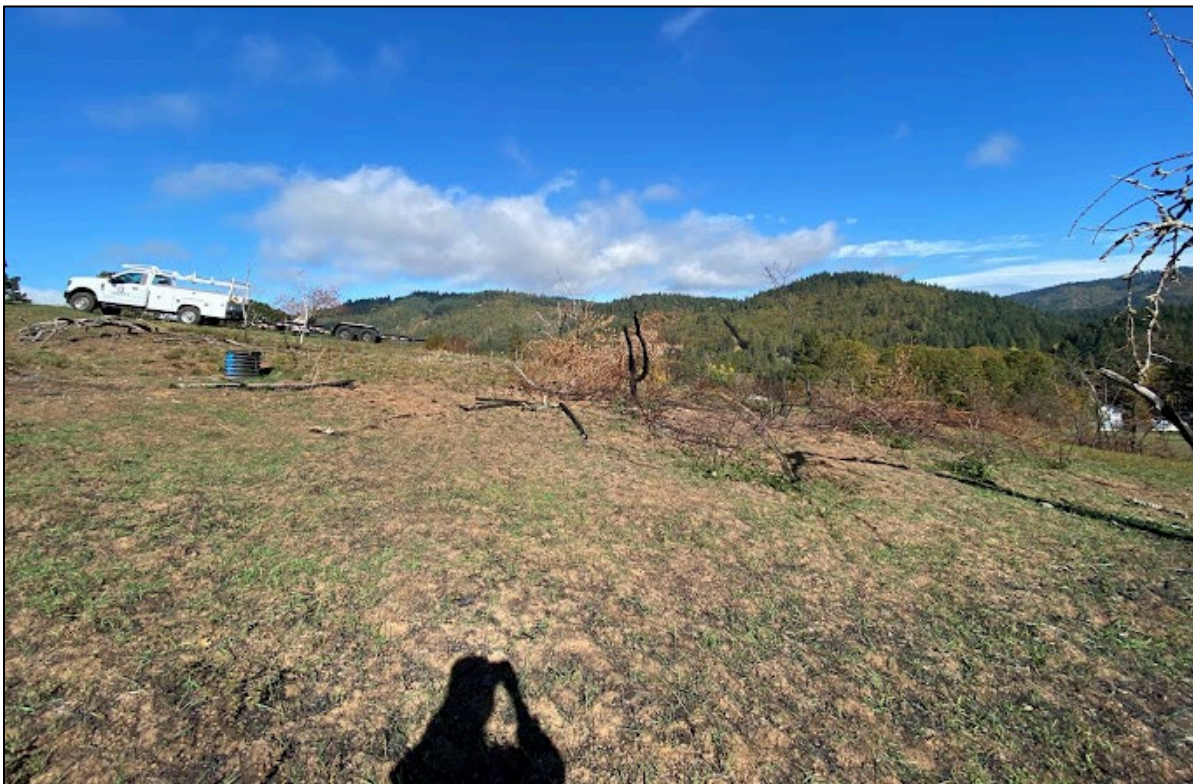
Photo 2: Current site conditions (taken from TP-4, facing north).

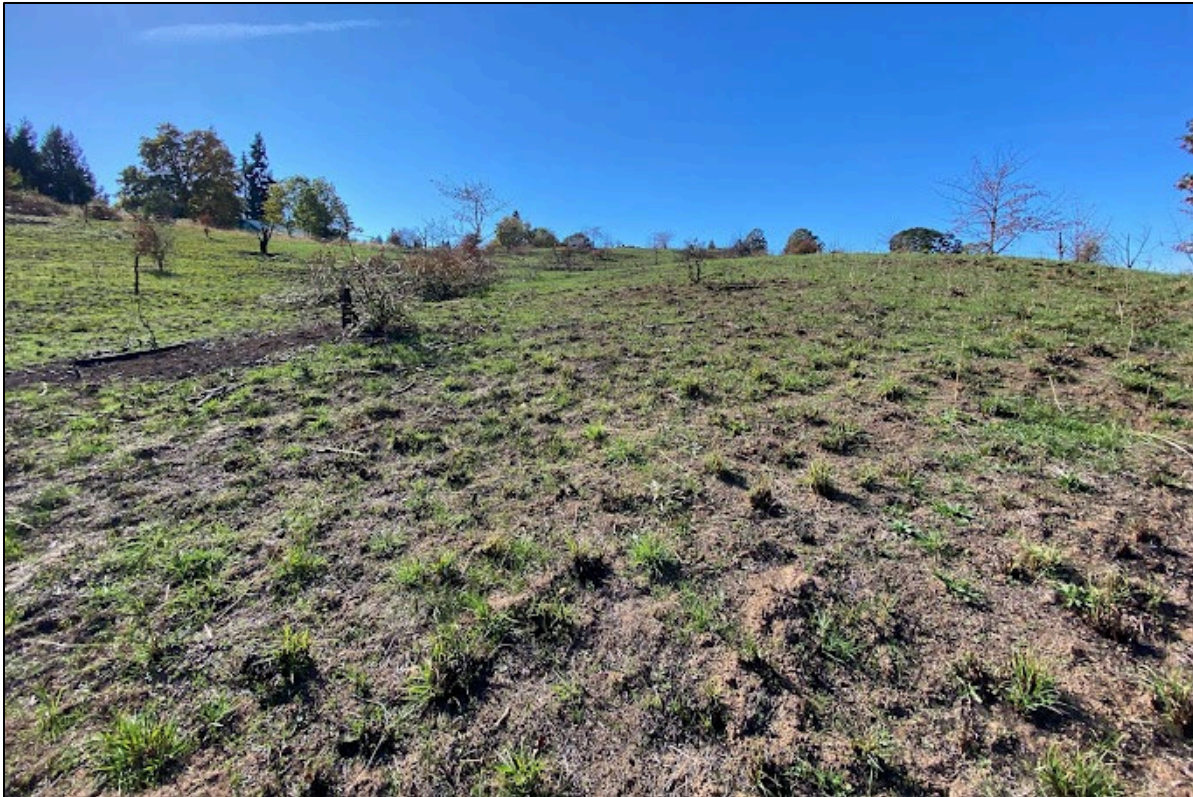
Photo 3: Current site conditions (taken from TP-8, facing southwest).

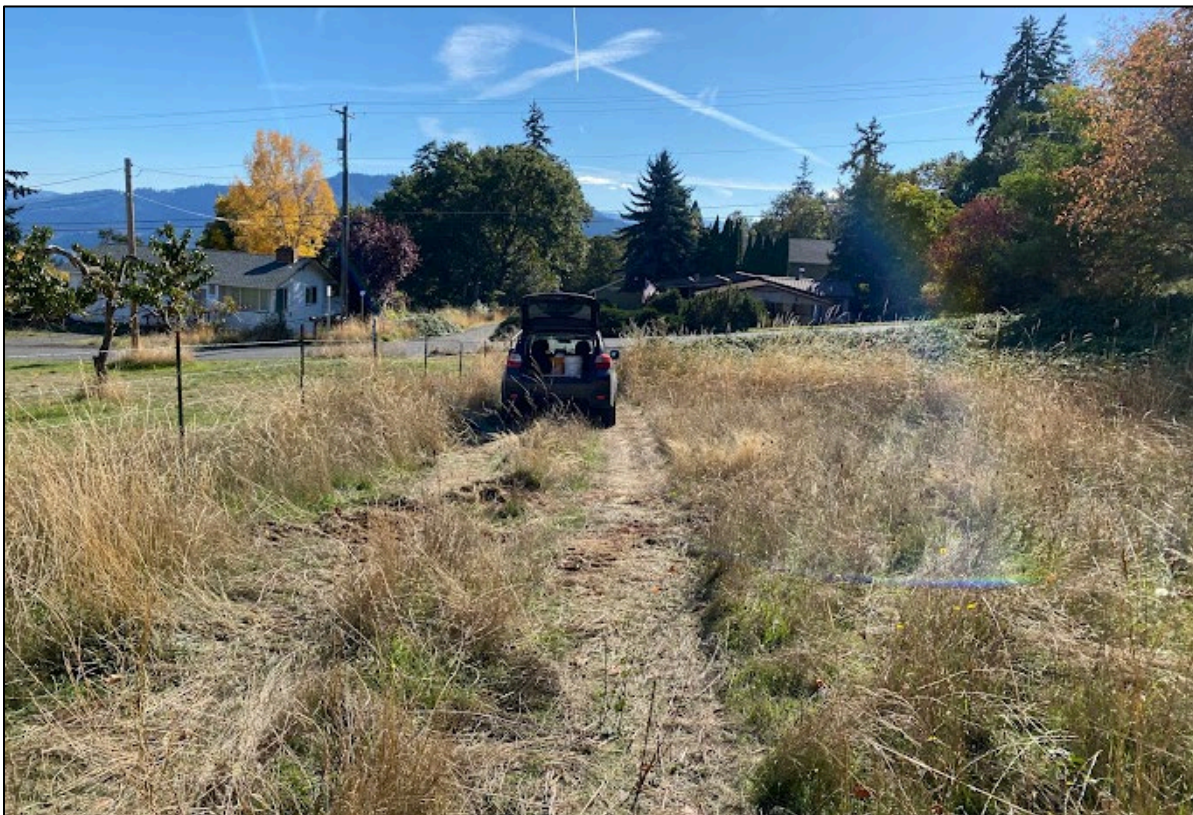
Photo 4: Current site conditions (taken from TP-11, facing Northwest Spring Street to the south).

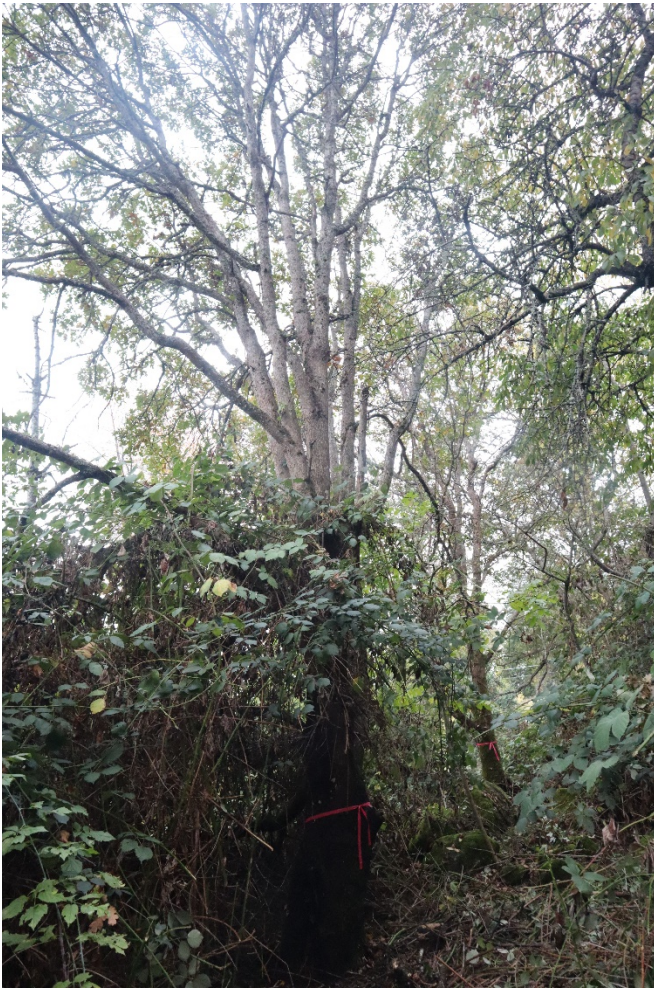
**Photo 9725. View south along fence line towards southwest corner of property. Oak #2 in foreground, Oak #1 in background.
Photo David M. Braun., November 3rd, 2023**

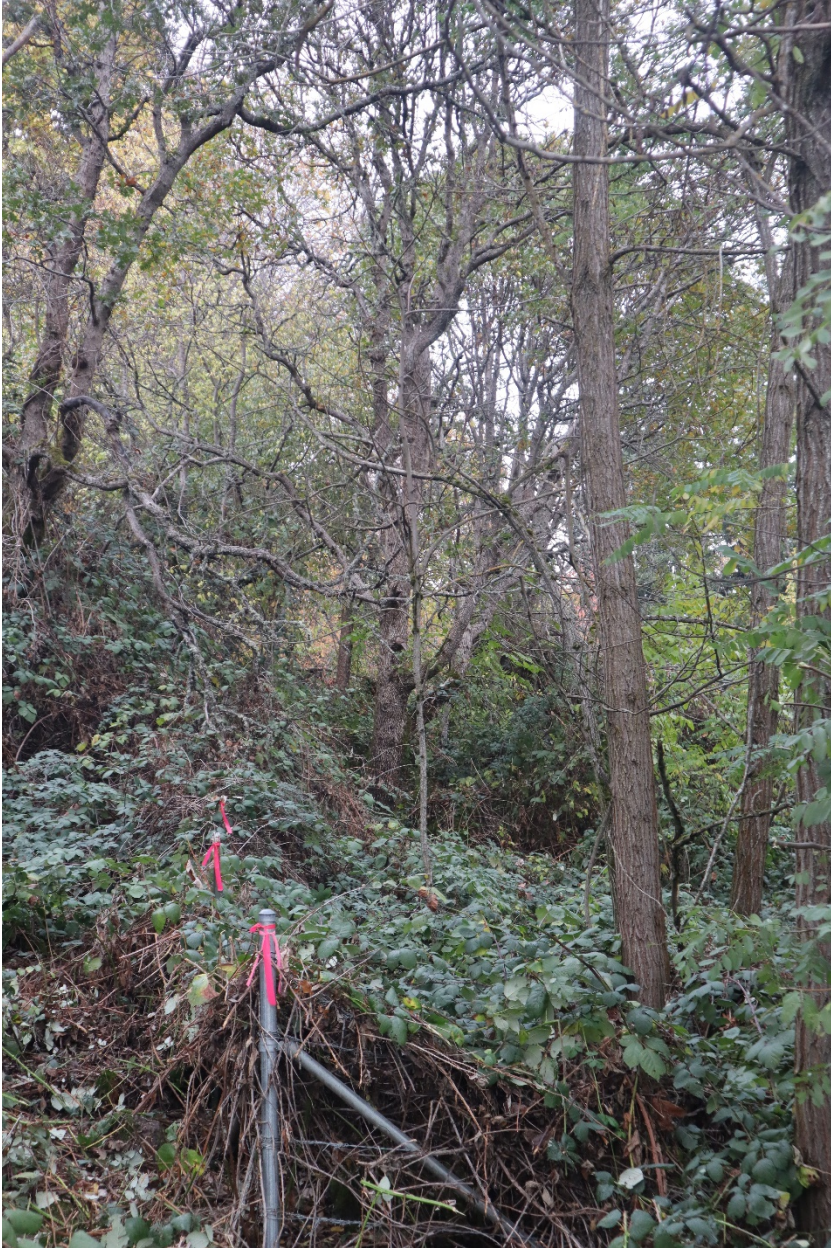
Photo 9718. View north from Spring St. of southwest corner of property and along west fence line. Oak #1 at center, Oak #3 beyond it to left; Oak #2 obscured by blackberries behind and to right of Oak #1. Trees to right are Black Locust < 18 in. dbh. Photo David M. Braun., November 3rd, 2023

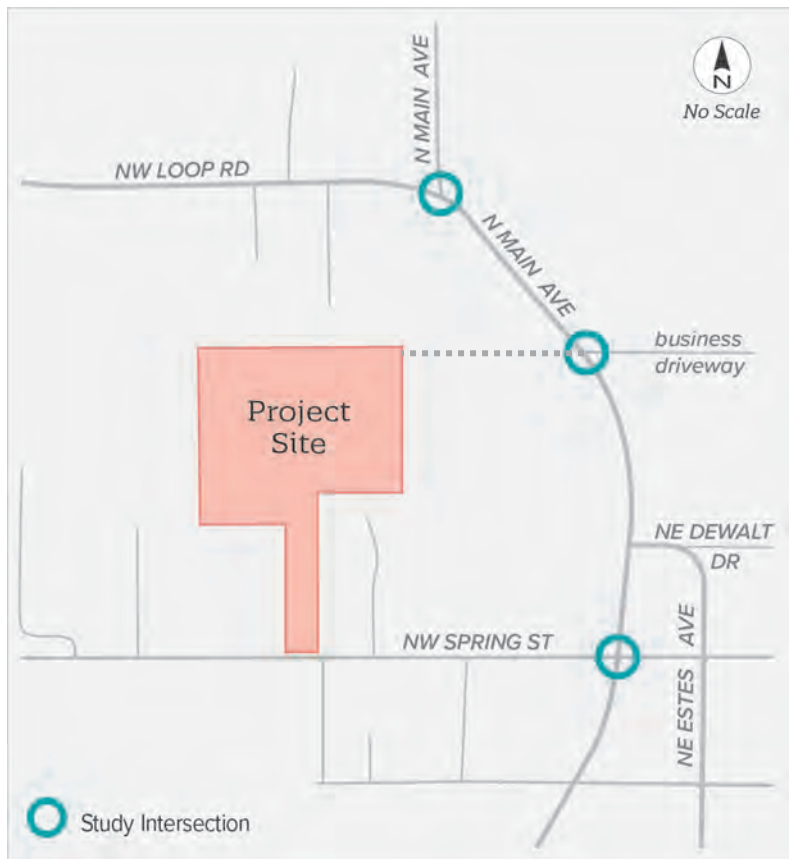
FIGURE 1. PROJECT LOCATION AND STUDY INTERSECTIONS

1. Main Avenue/Loop Road (Two-Way Stop-Controlled)
2. Main Avenue/New Public Street/Business Driveway (Two-Way Stop-Controlled)
3. Main Avenue/Spring Street (Two-Way Stop-Controlled)

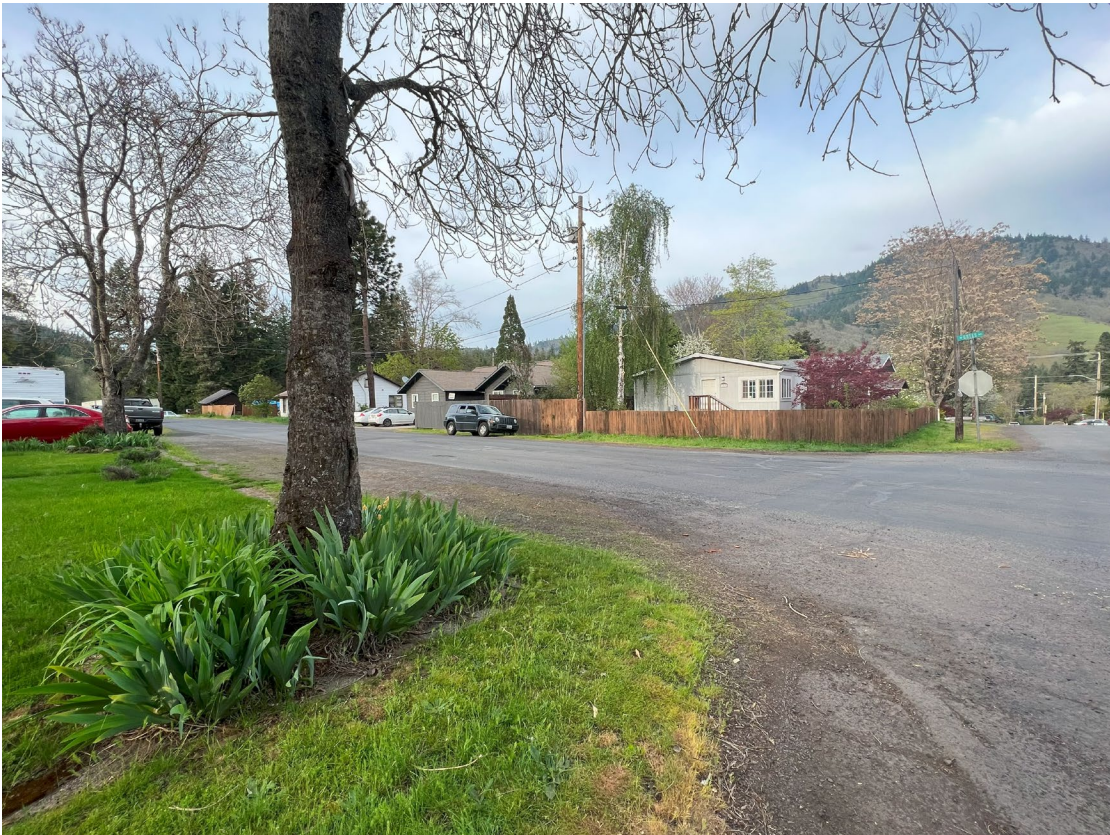
White Salmon has designated a network of streets and walking paths as a Safe Routes to School (SRTS) network connecting to Whitson Elementary, the only public school inside the city limits. The network includes portions of Center, O’Keefe, Tohomish, Hood, Main, Jewett, Wauna, Fields, and Spring streets (Figure 7). This plan includes a December 2021 resolution considered by Klickitat County, which would extend the SRTS network to include areas outside the city limits connecting to Henkle Middle School and Columbia High School along NW Loop Road and NW Jewett Boulevard. Appropriate safety and access improvements for students along and across school walking and bicycling routes may include traffic calming (e.g., speed humps and neighborhood traffic circles), crosswalk and crossing improvements, modifications to speed limits and zones, lighting improvements, pathway connections, and bikeways. Projects along and across this SRTS network may be eligible for Washington State Safe Routes to School program funding (see the Funding section of Chapter 6 below for further detail). The City will work with the White Salmon Valley School District to update the SRTS map shown on the following page (Figure 7).

Many streets do not have sidewalks.

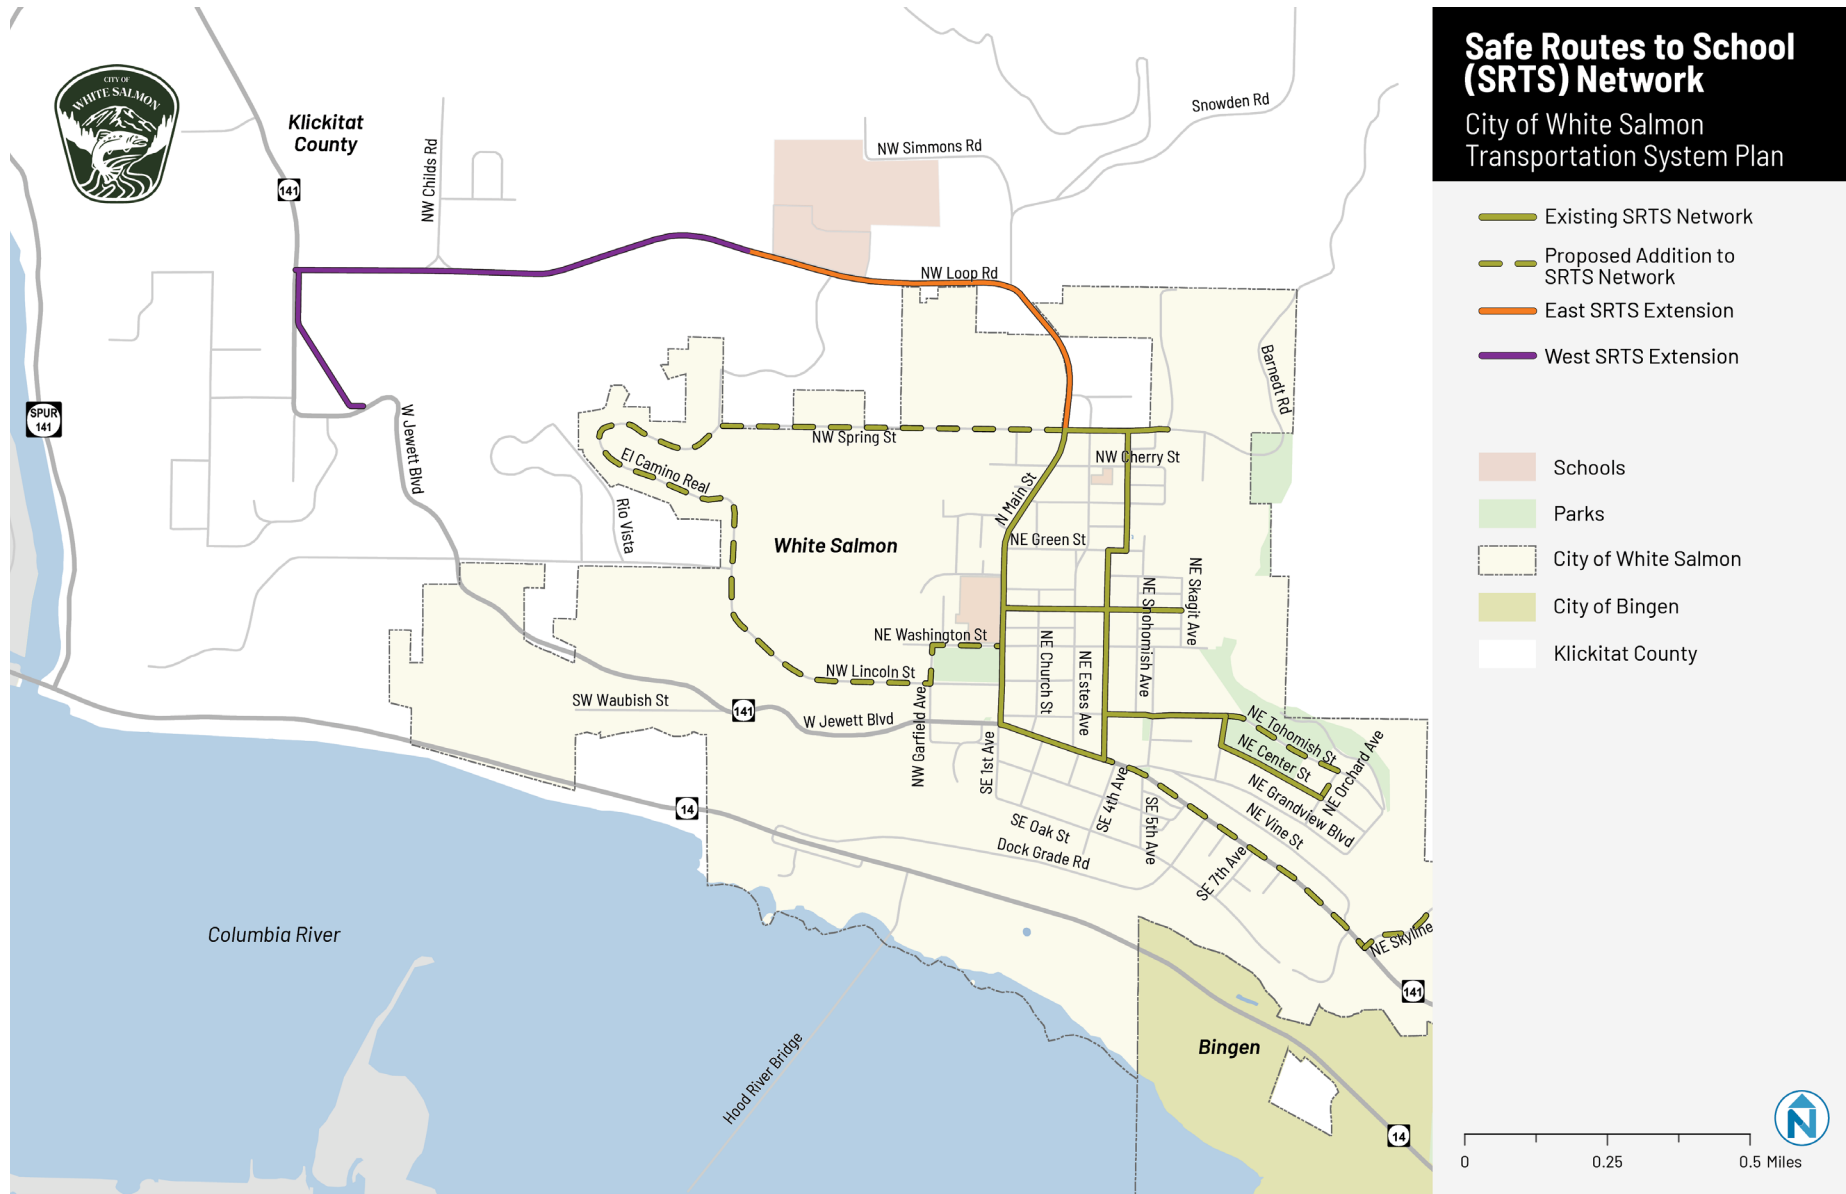
Figure 7 Safe Routes to School Network and County Extensions

FINDING: Per RCW 47.04.300 and the adopted Safe Routes to School network shown on Figure 7 of the TSP and described on page 3-10 of the TSP (Exhibit 12b), staff finds shoulder improvements along NW Spring St, connecting the site to Main Street with a separated and protected paved shoulder, is consistent with RCW 58.17.110(2) for ensuring a proposed subdivision assures safe walking conditions for students to walk to school. A paved, protected shoulder is consistent Public Right-of-Way Access Guidelines (see Exhibit 17) by providing a stable, non-slip surface. If the City receives funding and constructs these SRTS improvements on the north side of NW Spring Street prior to when the applicant breaks ground, the City may elect to waive this requirement.
