City of White Salmon
 Recommendation to Planning
 Commission

Cherry Hill Estates Preliminary
 Plat

WS-SUB-2024.001 and WS-SEPA-2024.001
 Applicants: Alex Pedroza of HRK Engineering &
 Field Services, representing Cherry Hill NW, LLC
 and Cameron Curtis of Legacy Development
 Group

STAFF RECOMMENDATION
 Amended December 5, 2024

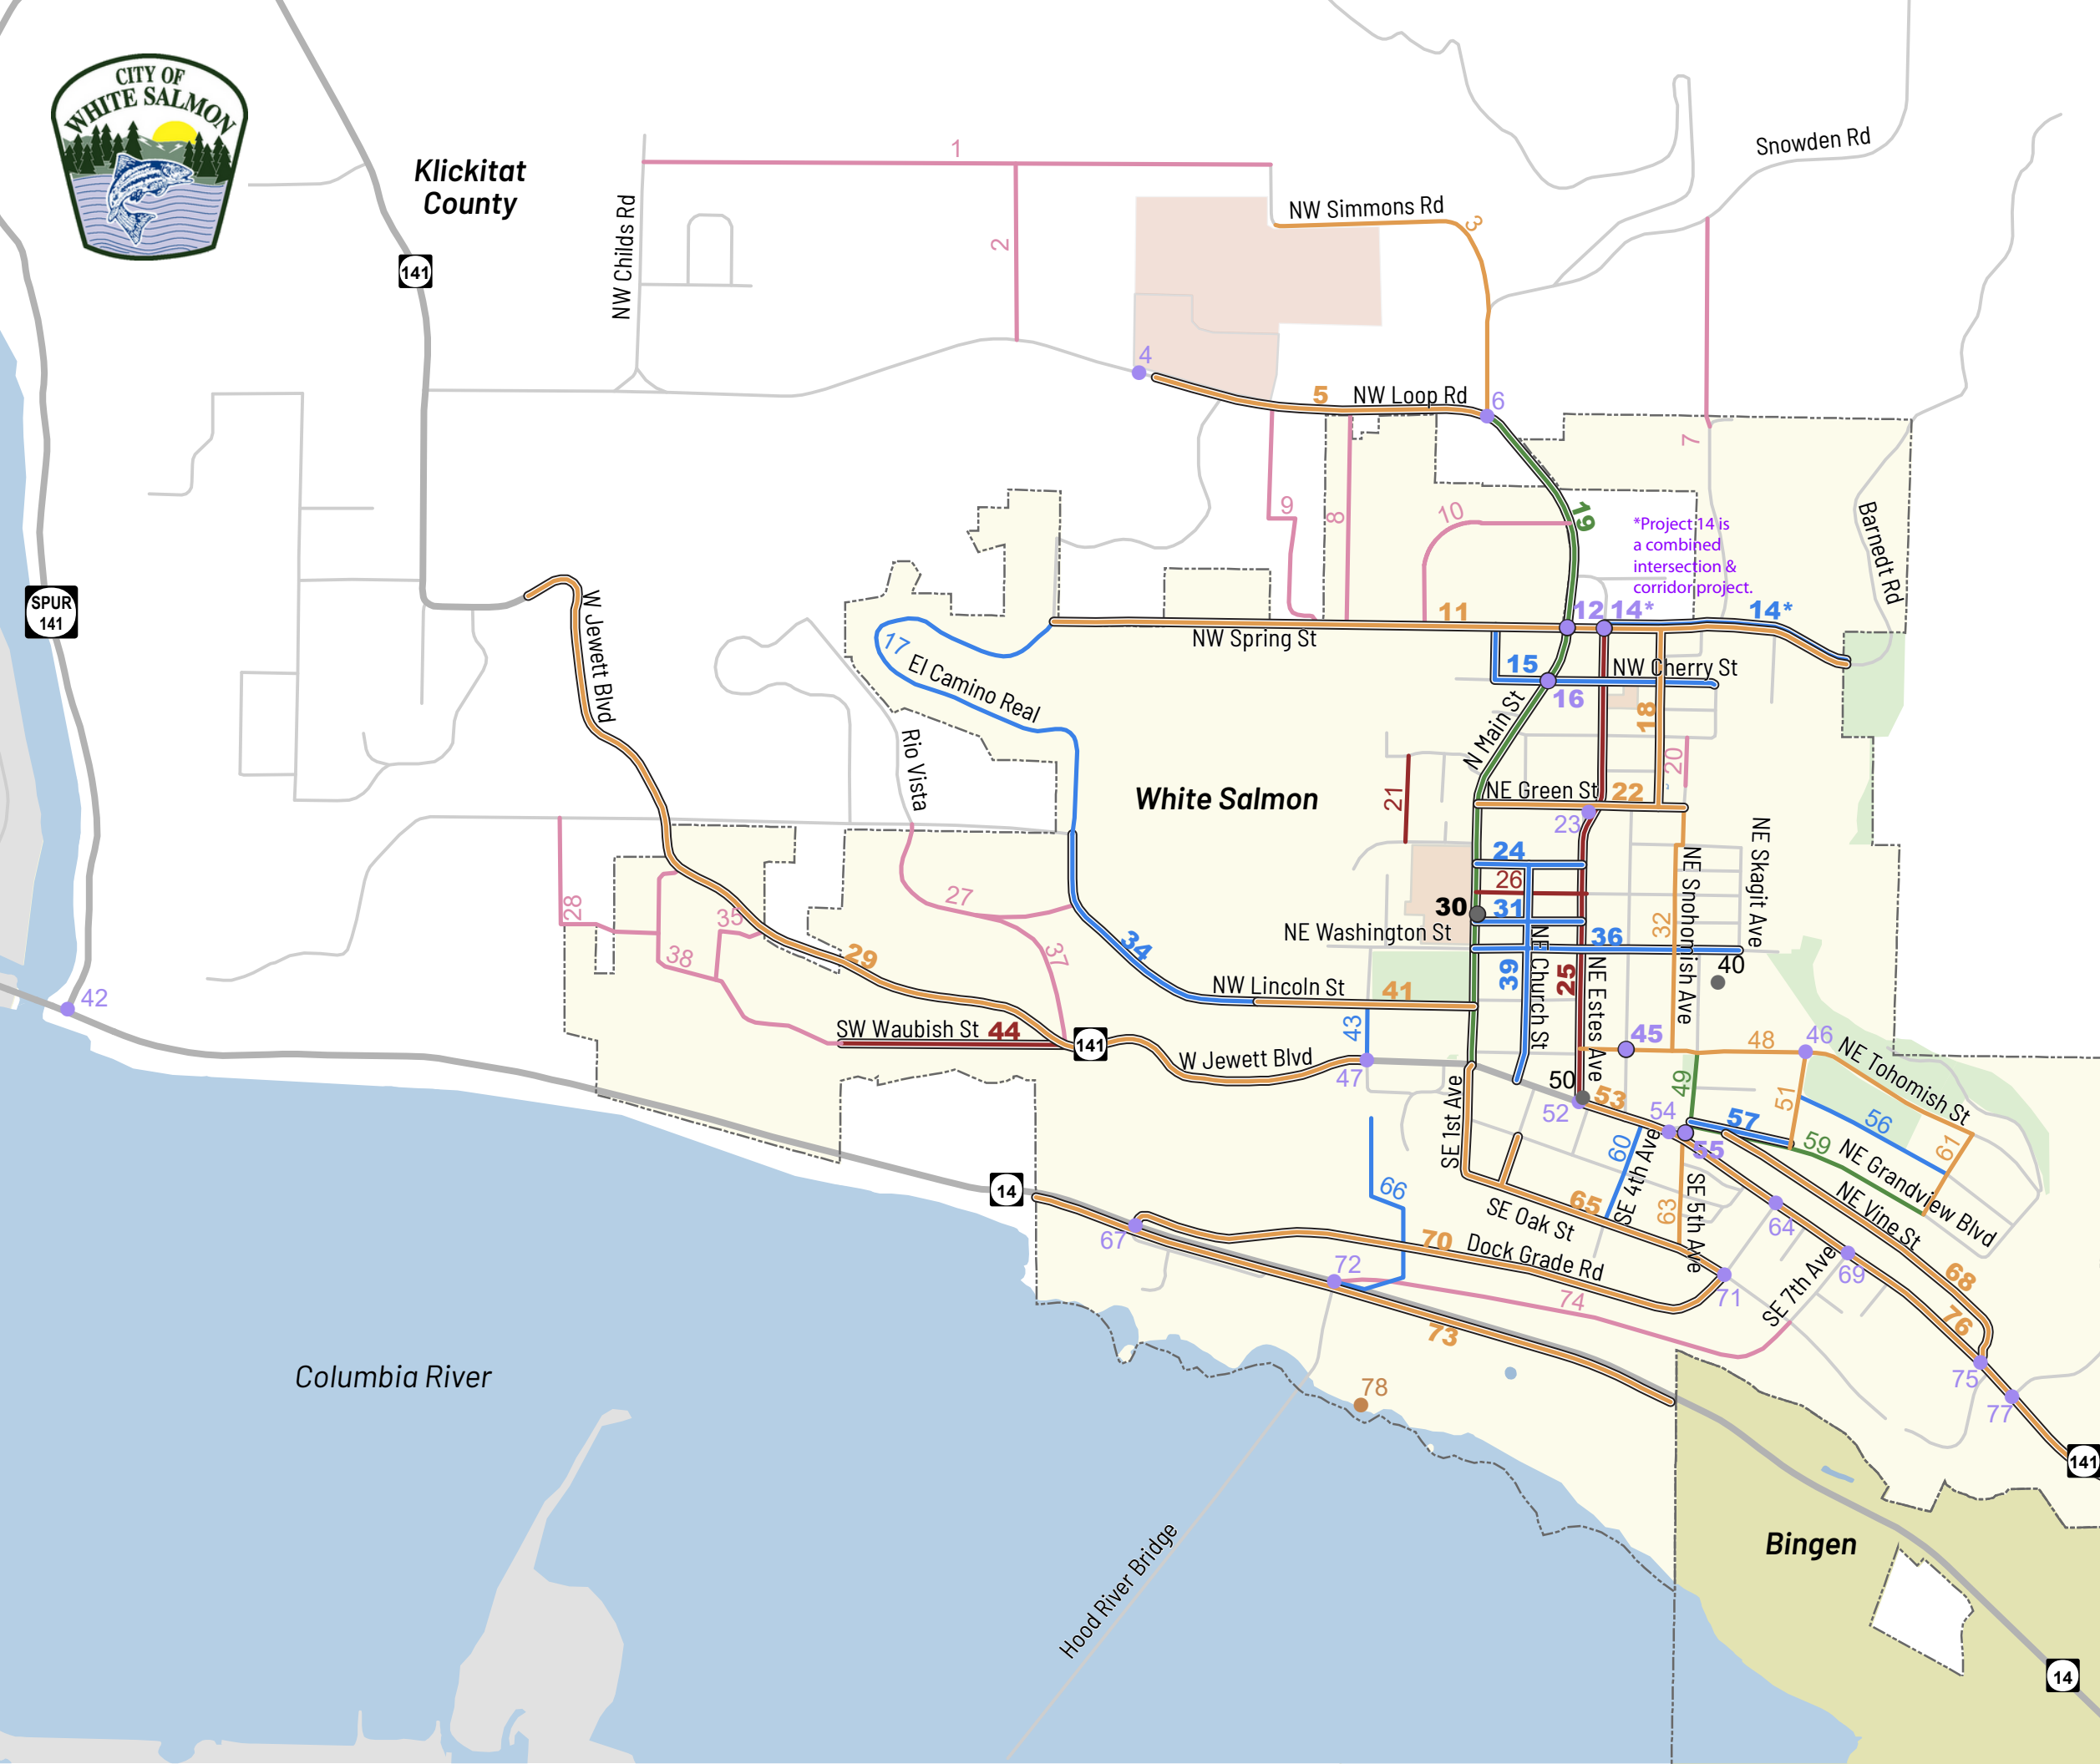
City of White Salmon Transportation System Plan

- Recommended TSP Projects
- Long-term projects (not in TSP time frame)
